Avian Impact Study for the Golden Gate Bridge
Suicide Deterrent System Project

Golden Gate Bridge
City and County of San Francisco, and Marin County, California

Prepared for:
Golden Gate Bridge Highway and Transportation District

Revised: November 25, 2009

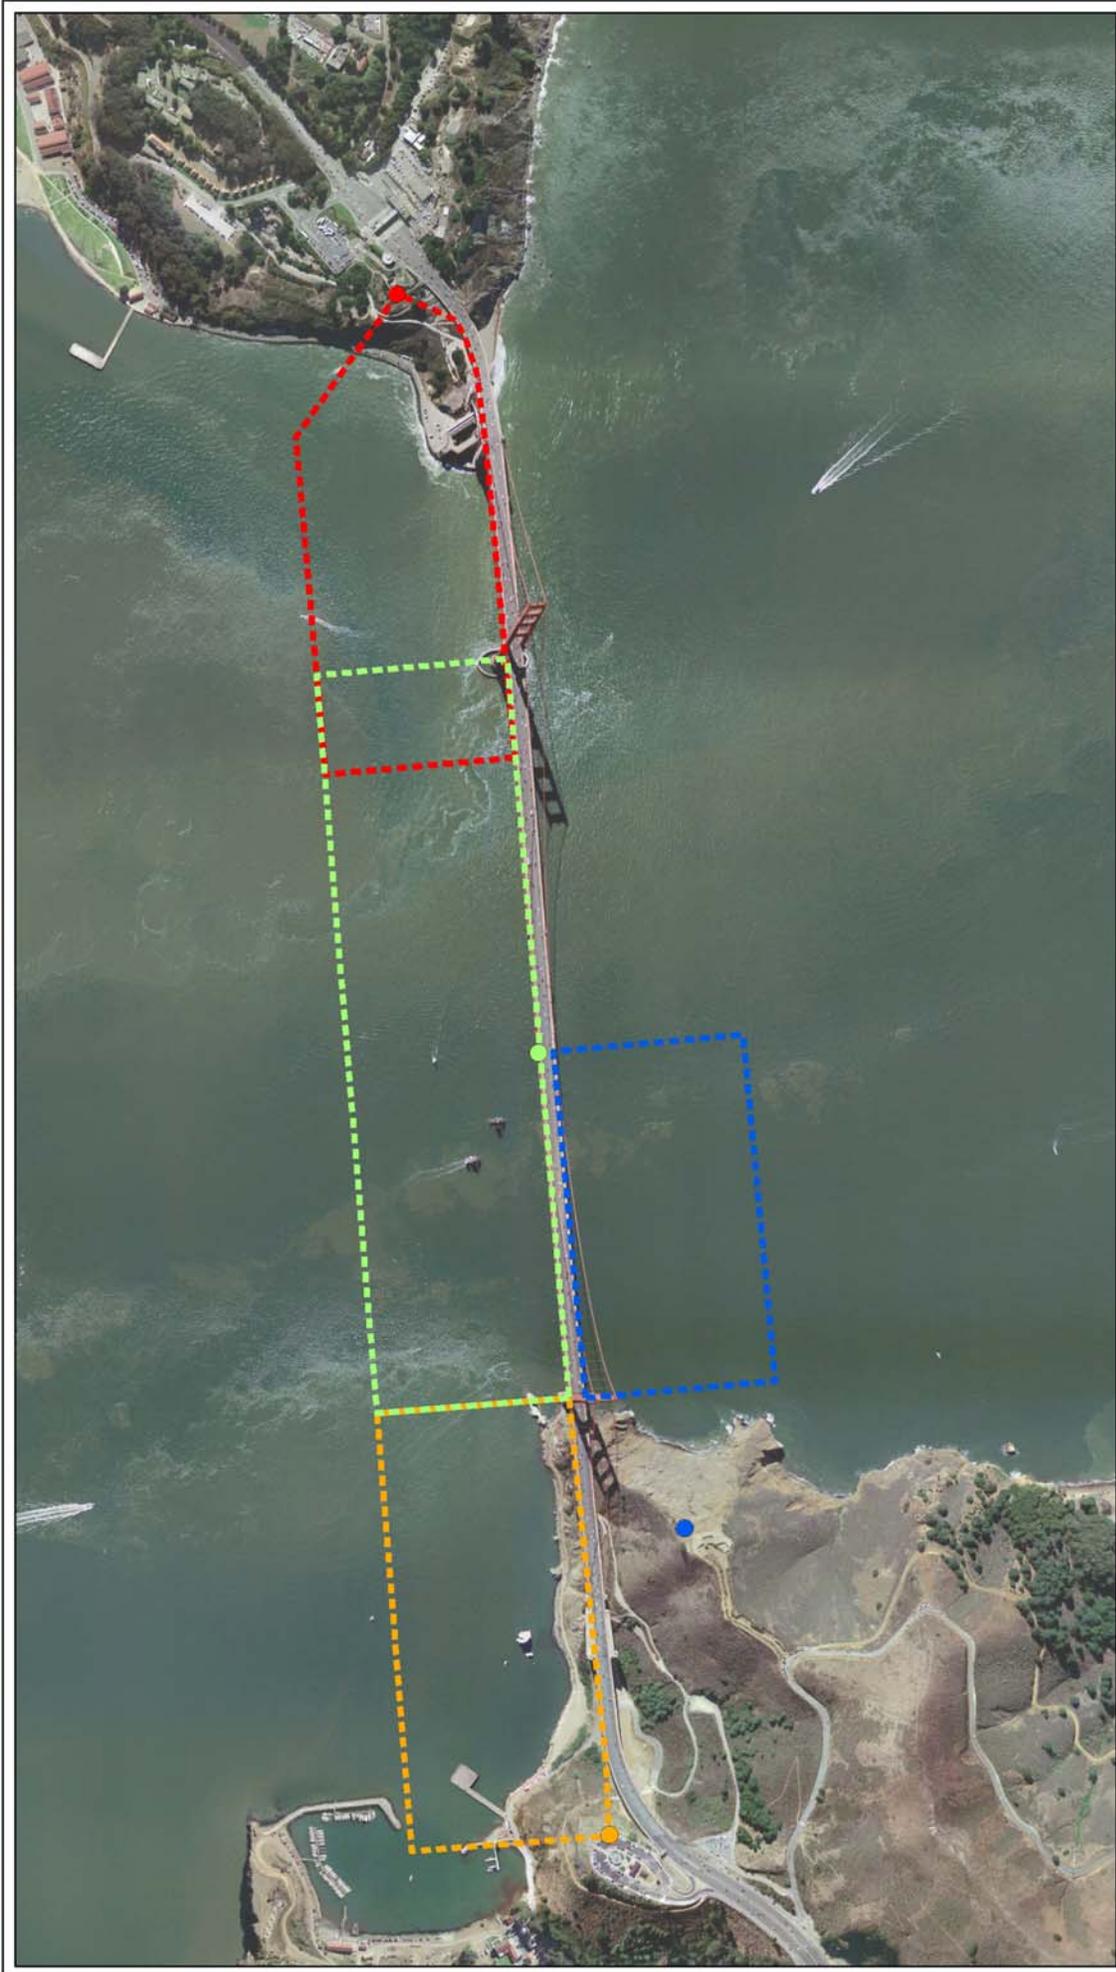
Figure 2. Location of the Golden Gate Bridge Survey Stations
Golden Gate Bridge Suicide Deterrent Project - Bird Surveys
San Francisco, California
 Source: USGS

- Survey Station 1: South Vista
 - Survey Station 2: North Vista
 - Survey Station 3: Mid Span
 - Survey Station 4: Marin Headlands
- ▭ Survey Station 1: South Vista Area Visible
 - ▭ Survey Station 2: North Vista Area Visible
 - ▭ Survey Station 3: Mid Span Area Visible
 - ▭ Survey Station 4: Marin Headlands Area Visible

Standardized surveys were conducted four times during winter 2008-2009. Observation stations were established at 4 different vantage points so that as much of the Bridge as possible could be observed (Figure 2). The west side of the Bridge was observable only

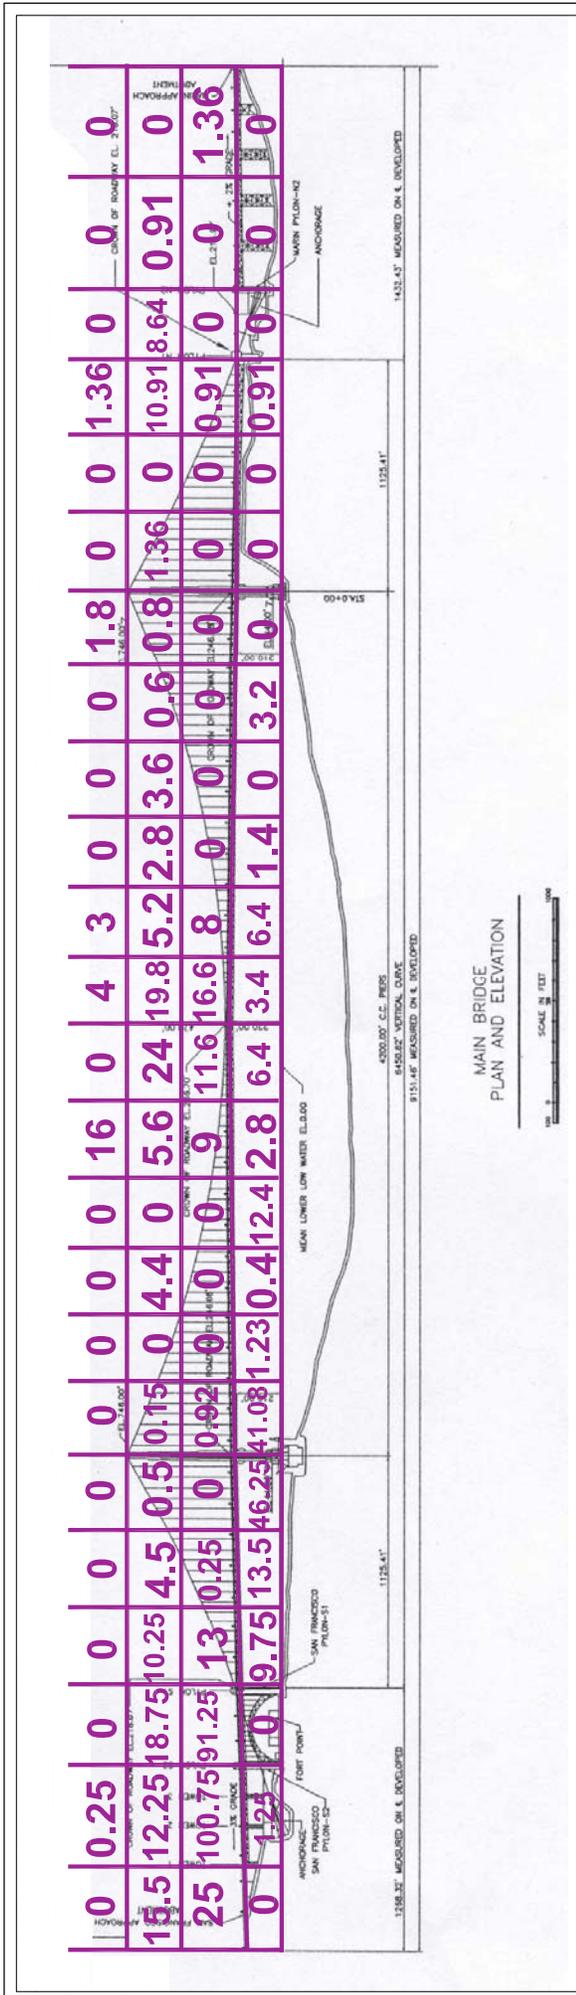
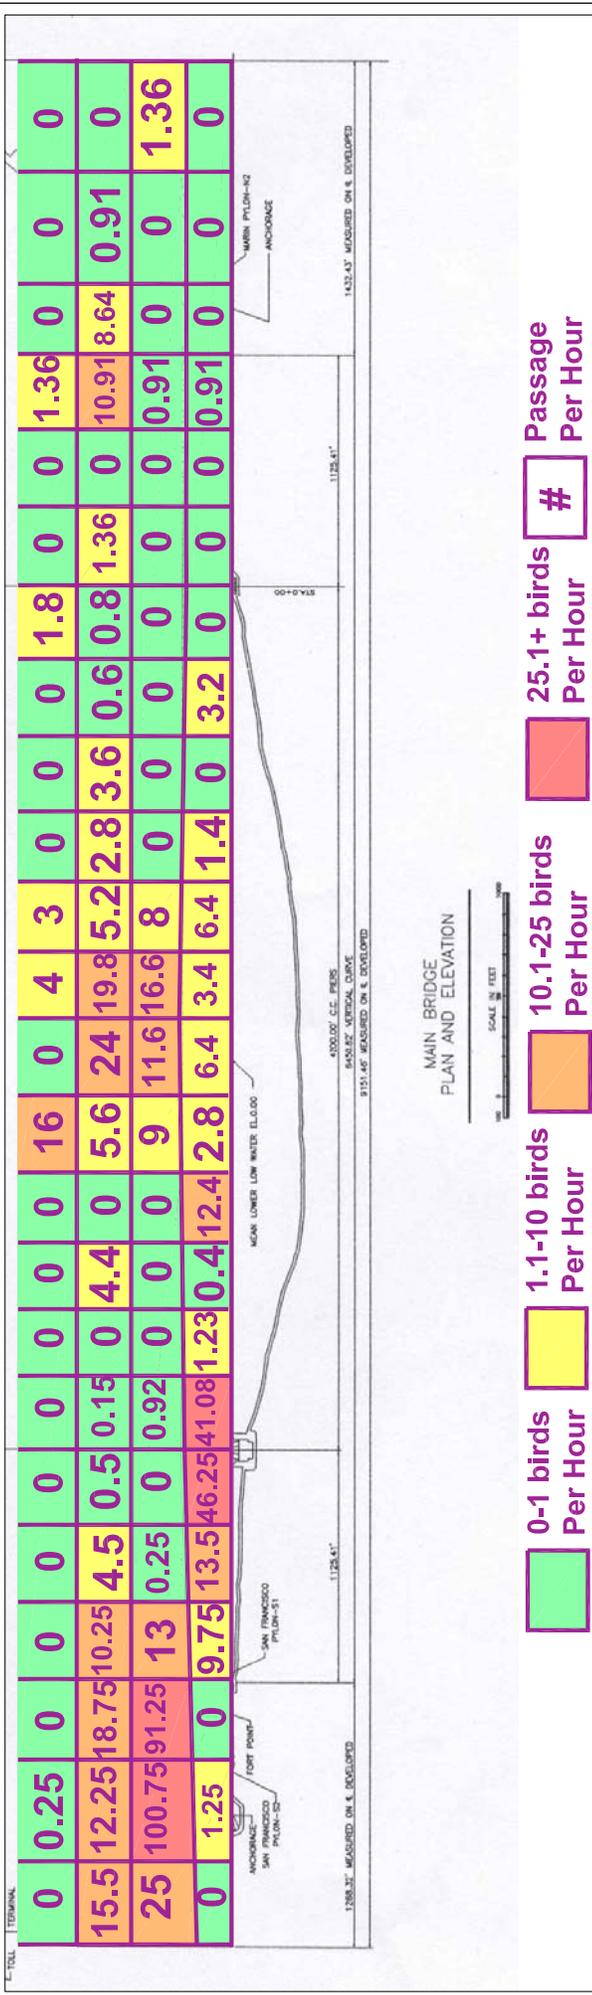
Figure 4. Bird Passage Through the Golden Gate Bridge
Golden Gate Bridge Suicide Deterrent Project - Bird Surveys
San Francisco, California

0-1 birds Per Hour

1.1-10 birds Per Hour

Birds tended to pass over the Bridge roadway in the central and southern portions of the Bridge, and they appeared to avoid flying close to the two main towers (Figure 4). Only one bird, a gull, was observed flying through the vertical cables above the roadway; all of the other birds flying at roadway level flew north or south to a point where they could cross through the cross-section of the Bridge by going over the cables at their lower points. At the northern end of the Bridge, on some days birds appeared to avoid flying over the cables north of the north tower. Birds tended to fly along the curve of the Marin Headlands, particularly when going east, and likely crossed over the Bridge far north of the north tower.

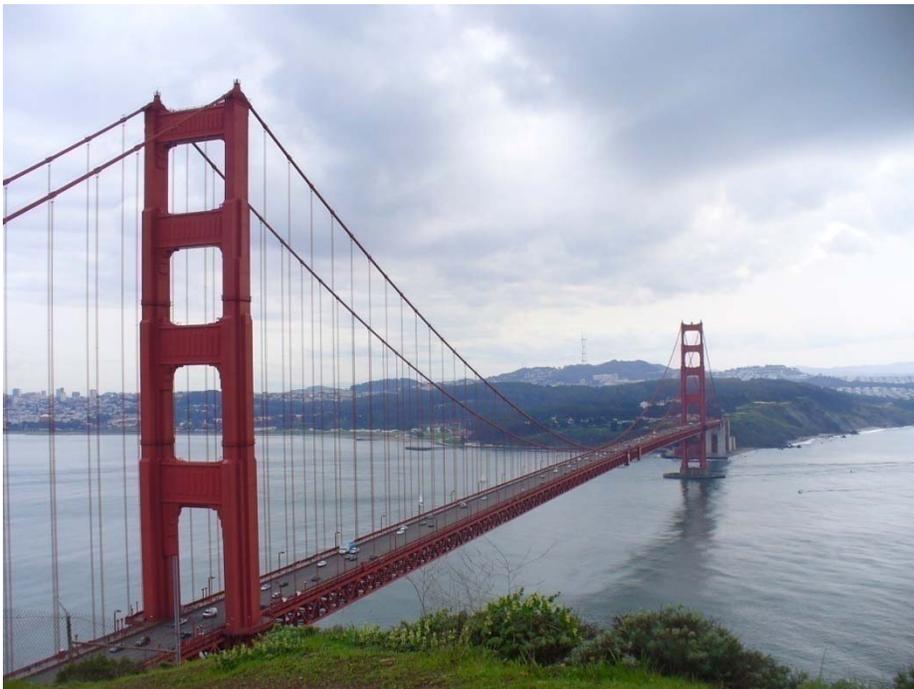
Photo B9. View of Golden Gate Bridge from survey Station 4 – Battery Spencer; looking south; February 18, 2009. Note peregrine falcon whitewash on right side of tower.

Abundant peregrine falcon whitewash was observed in several places on the north-west corner of the north Bridge tower on all visits starting on December 19, 2008 (Photo B9). A peregrine was seen flying over the south vista area at Station 1 on December 30, and the first sighting of a peregrine on the north tower was on January 11, 2009 (Figure 5, Figure 6).

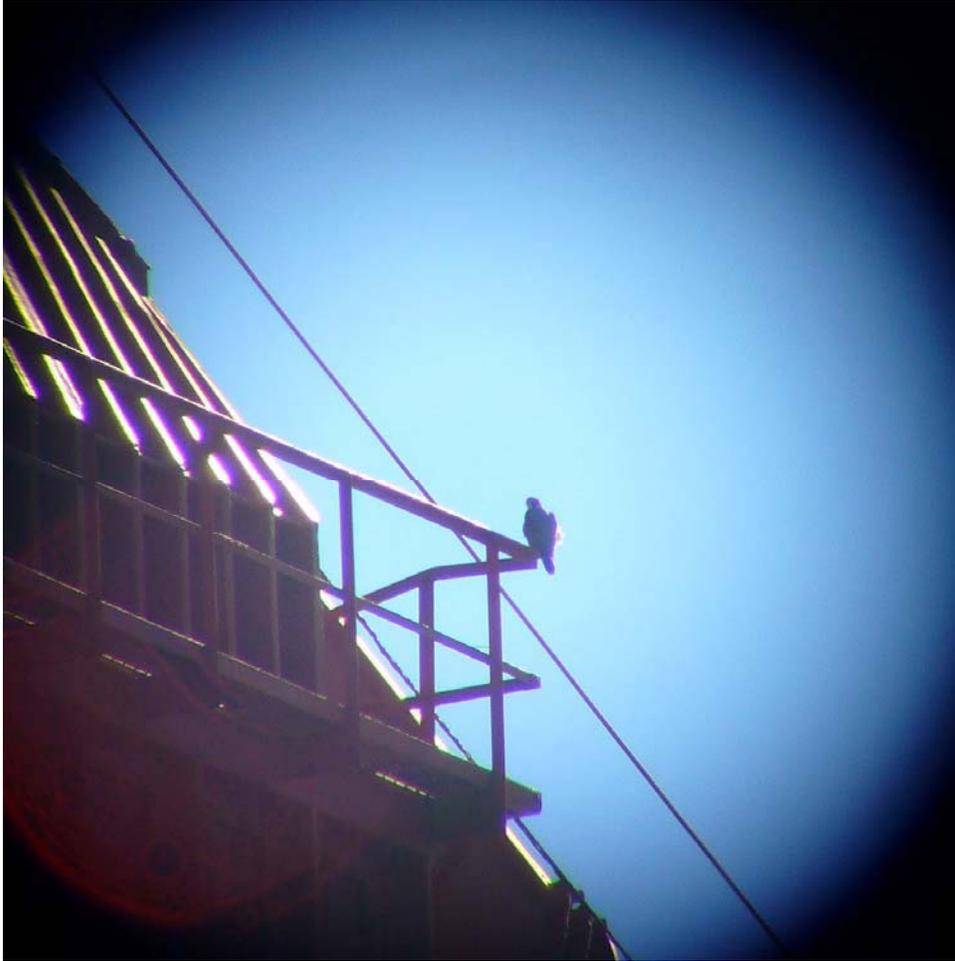
Photo B10. Peregrine falcon on north tower of Golden Gate Bridge from survey Station 4 – Battery Spencer; looking south; January 11, 2009.

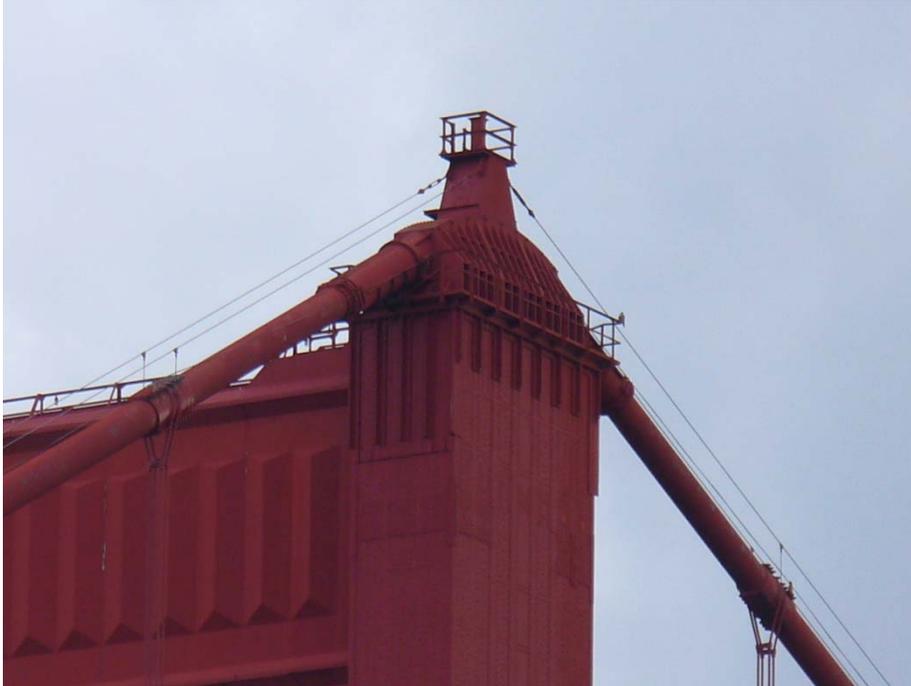
Photo B11. View of north tower of Golden Gate Bridge from survey Station 4 – Battery Spencer; looking south; February 18, 2009. Note peregrine falcon on top of railing center right.

No peregrines were seen on the January 24th visit. On February 18th, a peregrine was observed perching mid-way up the north tower on a railing, starting at 1:30 p.m., from Station 4 (Photo B11-13) There were apparent prey remains on the walkway below it, including feathers. At approximately 2:00 p.m., it flew south and west, and sparred with a red-tailed hawk that was circling in the area (including direct mid-air physical contact). This was approximately 2,000 feet west of the Bridge and approximately level with the top of the north tower. The peregrine then flew northwest and to a lower elevation, and disappeared out of sight somewhere west of the survey station on the Marin Headlands. At about 2:30 p.m., a peregrine (possibly the same bird) was again on the tower, now at the top railing. At 2:45 p.m. a large dark helicopter flew over the Bridge within 1,000 feet of the bird, at about its elevation. This caused the bird to startle and fly in circles close to the tower, and in several minutes it landed on top of the cable about 20 feet south of the previous perch on the tower (Photo B13). It was still there at 3:11pm. At 4:45 p.m. it was observed again, circling about the north tower. At 5:24 p.m. it flew from the north tower to the south tower where there appeared to be an additional peregrine, although it was seen for less than one second; one did several short display flights characteristic of pair bonding.

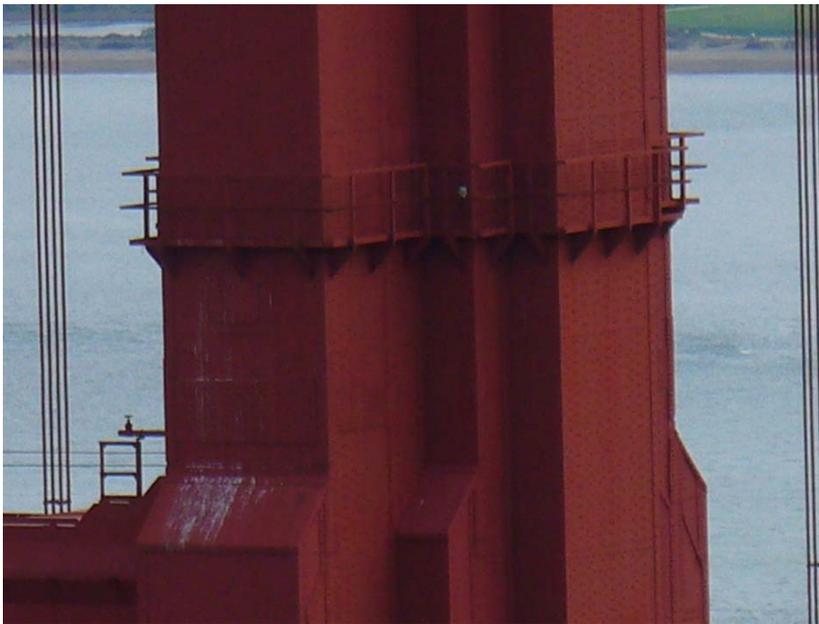
Photo B12. View of north tower of Golden Gate Bridge from survey Station 4 – Battery Spencer; looking south; February 18, 2009. Peregrine falcon is on top of railing just above center and whitewash lower left.

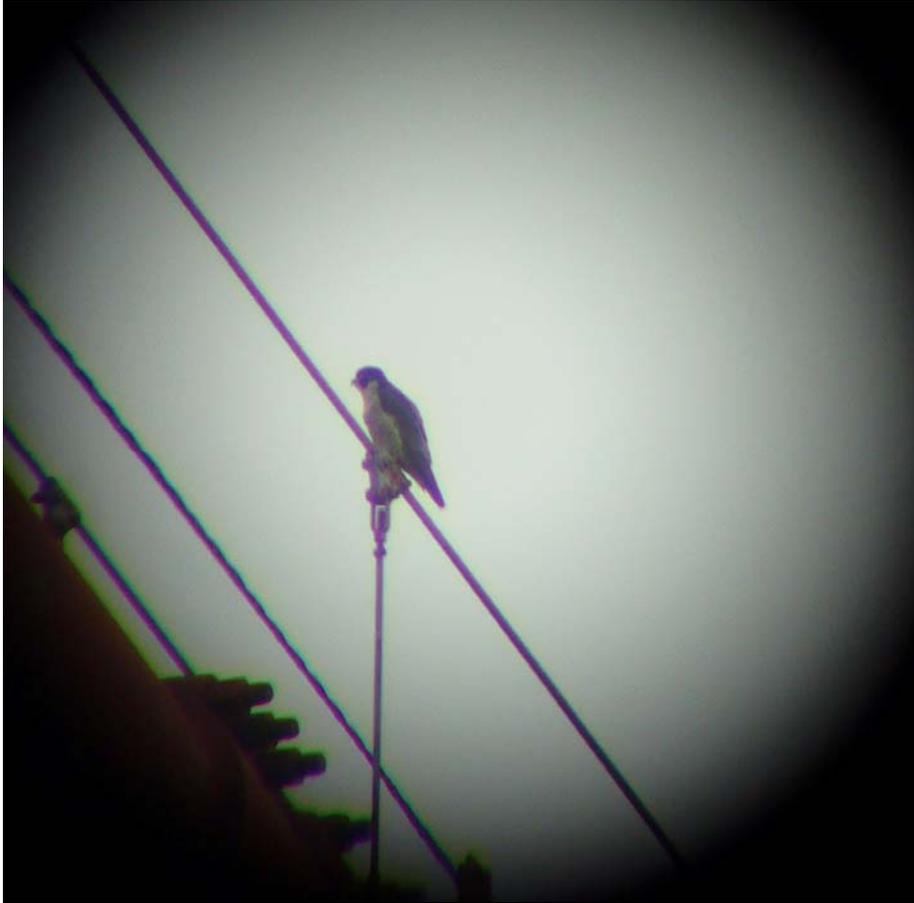
Photo B13. View of peregrine falcon on Golden Gate Bridge from survey Station 4 – Battery Spencer; looking south; February 18, 2009. Peregrine is perched on cable railing south of north tower after flushed by helicopter.

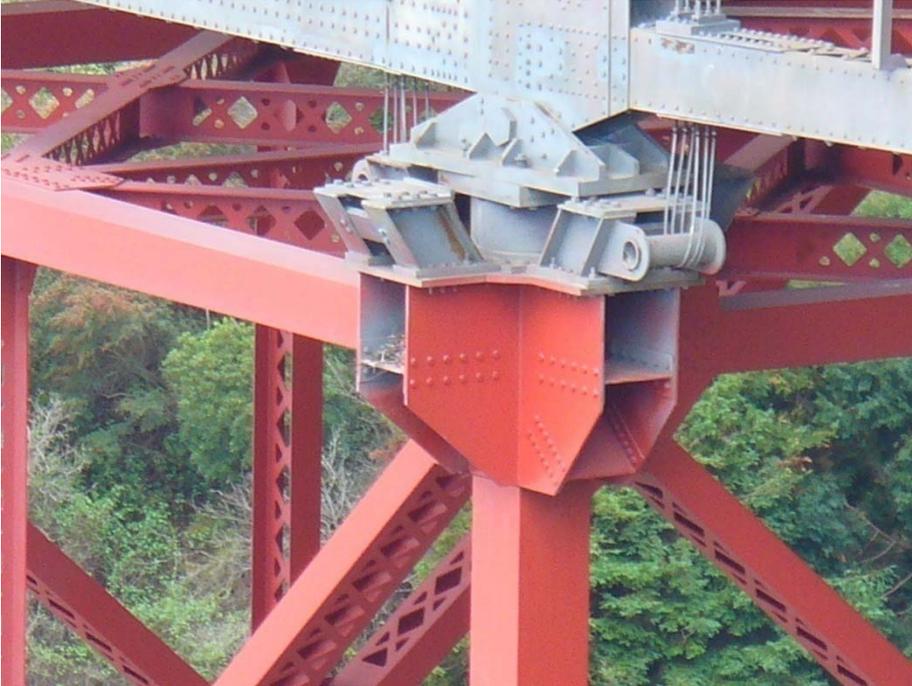
Photo B14. Probable old red-tailed hawk nest on Golden Gate Bridge north of Marin anchorage, from Station 2. January 25, 2009.

At least one red tailed hawk was observed on and around the northern end of the Bridge and on the Marin Headlands on December 23, 2008, and January 4, January 24, and February 28, 2009 (Figure 6). Remains of an apparent old nest were seen on December 23 (Photo B14), within a sheltered area immediately below the bottom chord of the exterior main truss at the top of the third tower north of the Marin anchorage. An apparently active nest was observed on February 18 at the top of the second tower north of the Marin anchorage (Photo B15-16). No hawk was seen on this nest or entering or leaving it, but an attentive hawk perching on the third tower seemed to be interested in the nest and looked at it while flying closely past it several times. This nest location appears to be very close to the northern end of the proposed netting system footprint.

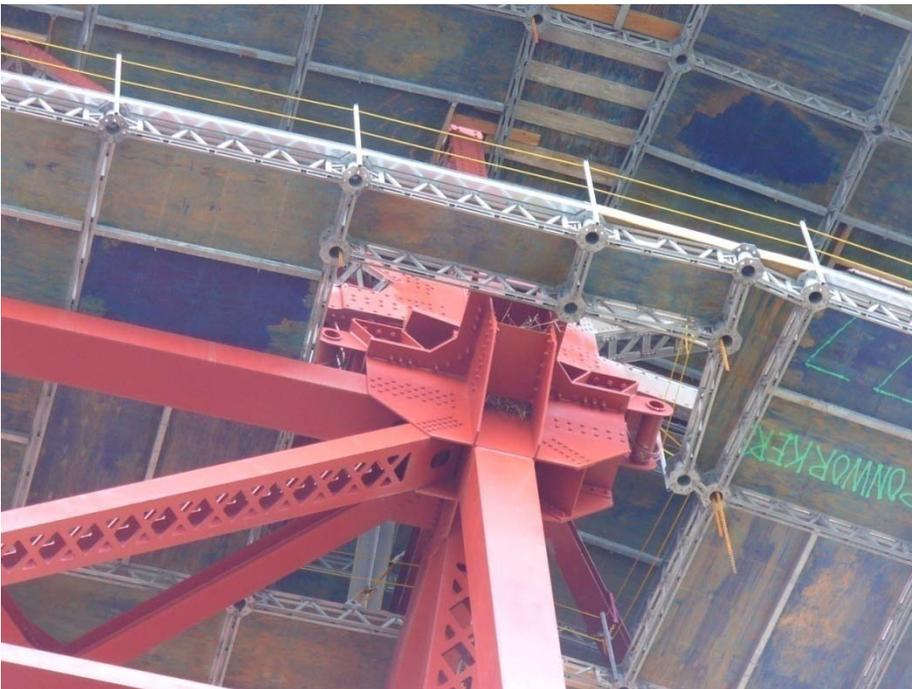
Photo B15. Probable active red-tailed hawk nest on Golden Gate Bridge north of Marin anchorage, view from below; February 18, 2009.

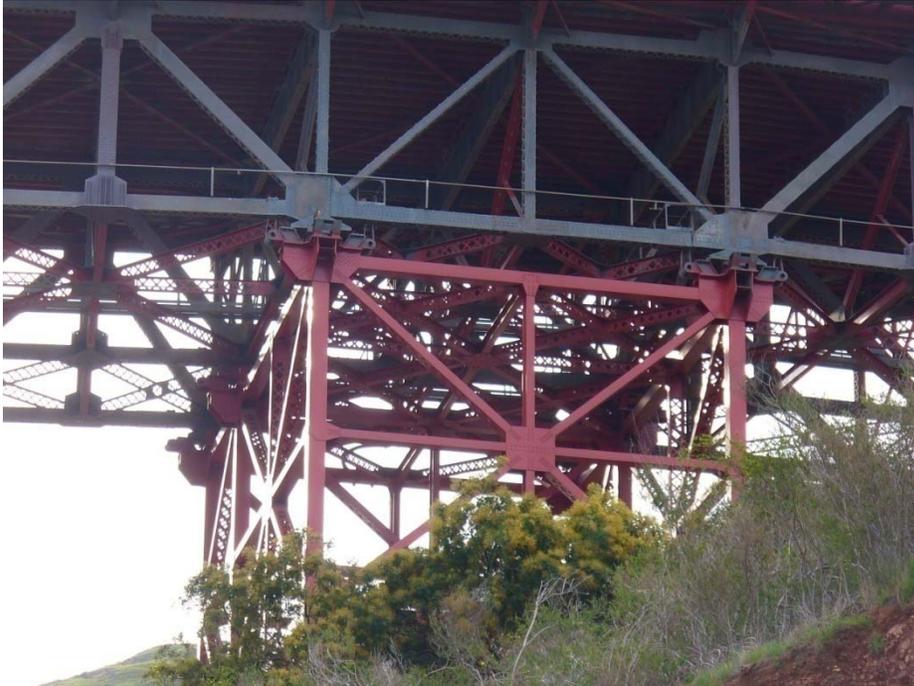
Photo B16. View of red-tailed hawk nest on Golden Gate Bridge north of Marin anchorage; February 18, 2009.
